**Agreement No. CE 59/2020 (EP)
Environmental Monitoring and
Audit for Disposal Facility to the
East of Sha Chau (2021-2026)
– Investigation**

Monthly EM&A Report for
Contaminated Mud Pits to the East of Sha Chau
– September 2023

October 2023

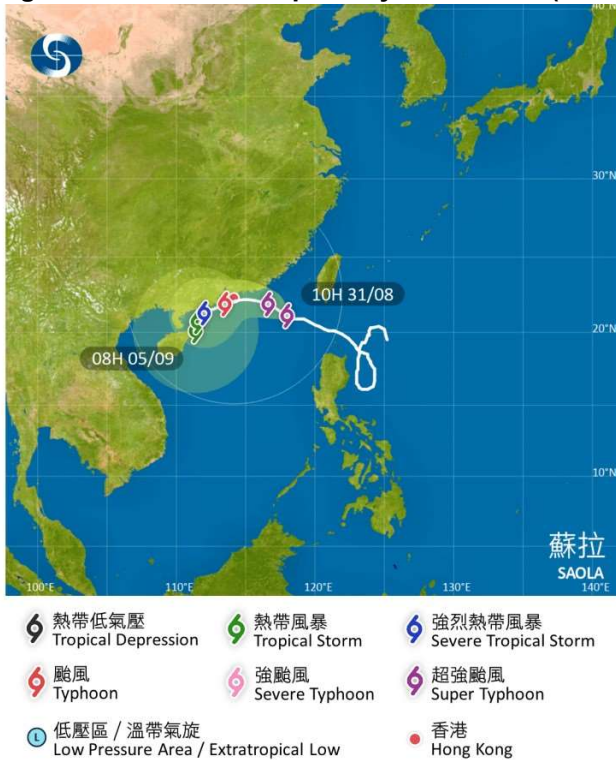
Figure 2.4: Track of Tropical Cyclone Saola (Source: Hong Kong Observatory)

Sampling for Sediment Chemistry after a Major Storm Event was conducted at nine (9) monitoring stations (see **Figure 2.3** for the locations of the monitoring stations) on 5 September 2023 after the visit of tropical cyclones Saola, which led to the issue of No. 8 Storm Signal on 1 September 2023. The tracks of Saola are shown in **Figure 2.4**.

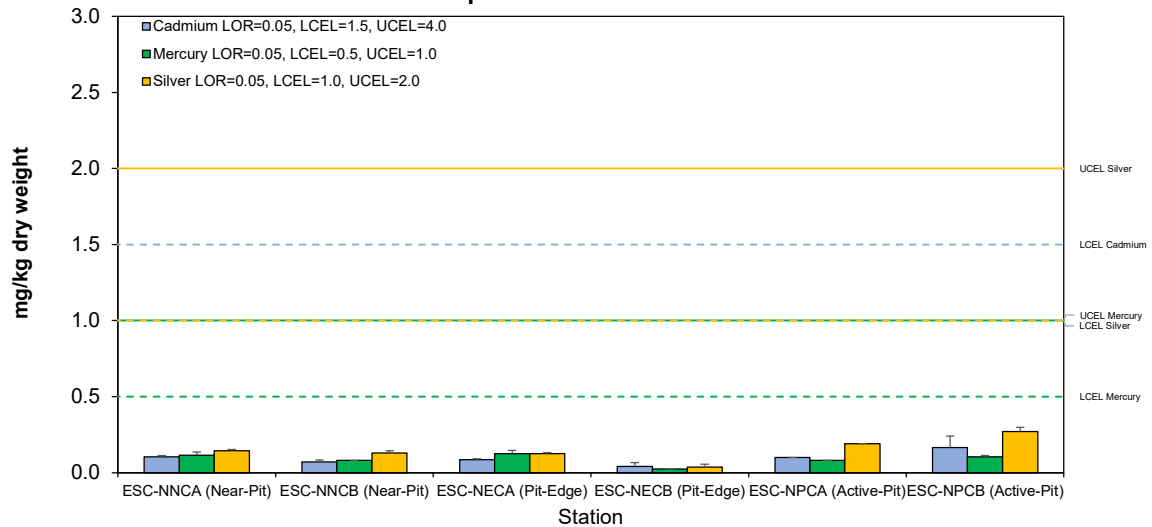
The concentrations of most inorganic contaminants were lower than the Lower Chemical Exceedance Levels (LCELs) at all stations, except for Arsenic. The concentrations of Arsenic were higher than the LCEL at Near-Pit station ESC-NNCA and Pit-Edge station ESC-NECA. (**Figures 11 and 12 of Appendix C**).

Figure 12: Concentration of Metals (Cd, Hg, Ag; mg/kg dry weight; mean + SD) in sediment samples collected from Pit Specific Sediment Chemistry Monitoring for ESC CMP Vb in September 2023

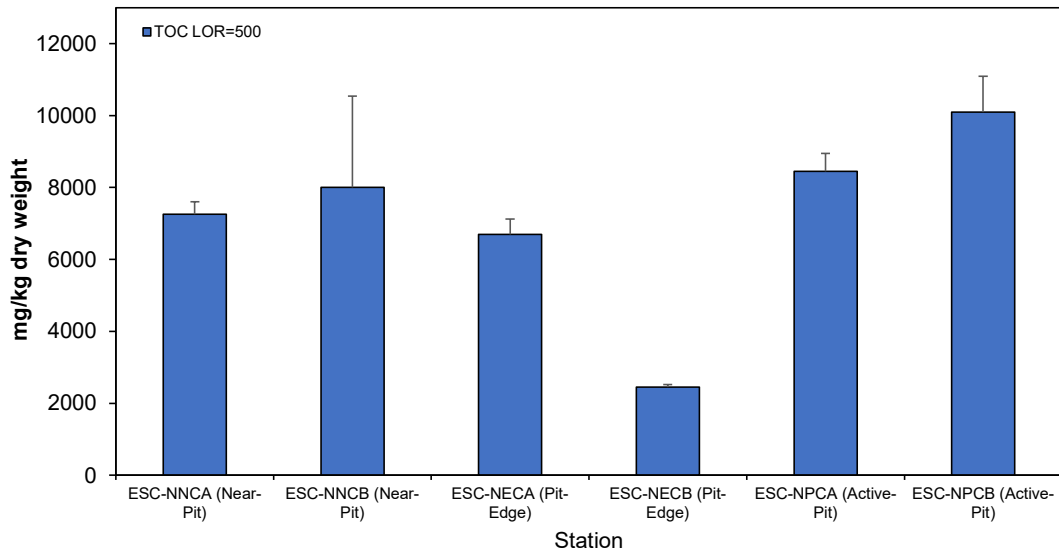
For organic contaminants, the concentrations of Total Organic Carbon (TOC) were higher at Active-Pit station ESC-NPCB. (**Figure 13 of Appendix C**). The concentrations of Low Molecular Weight Polycyclic Aromatic Hydrocarbons (PAHs) were higher at Active-Pit station ESC-NPCB. (**Figures 14 of Appendix C**).

Figure 13: Concentration of Total Organic Carbon (TOC) (mg/kg dry weight; mean + SD) in sediment samples collected from Pit Specific Sediment Chemistry Monitoring for ESC CMP Vb in September 2023
